Zenair Europe

Service Letter

S.L. Number:	ZE-2009-01
Date of issue:	June 1, 2009
Subject:	Verification of the proper installation of the “Flap Stops” (Part N° 6S3-1)
Affected Models:	All Zenair Zodiac CH 601XL/CH 650 (ULM and Homebuilt Models).
Serial Number(s)	All
Manufactured by:	Czech Aircraft Works (CZAW) and others.
Purpose:	The purpose of this S.L. is to ensure that all affected models are only flown when “Flap Stops” are installed.
Directed Action(s):	<p>a) Before the next flight, inspect the outboard area of the flap gaps on the top surface of each wing, to establish that the “Flap Stops” have been properly installed (see illustrations on page 2).</p> <p>b) When properly installed, the flaps come to rest against the “Flap Stops” when in the “up” (retracted) position. There should be no free-play at the trailing edge of the flaps when flaps are in the “up” position (snug against the Flap Stop).</p> <p>c) If not installed (see photo below), obtain and install the missing parts according to this S.L. before the next flight.</p> <div data-bbox="764 1274 1212 1536" data-label="Image"> </div>

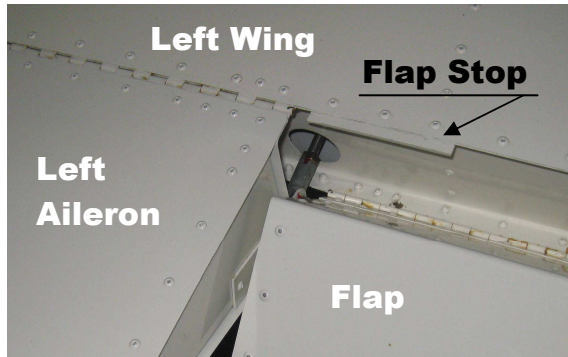
1) When in the “up” position, the flap must rest against a plastic “flap stop” (see photos below). Both left and right flaps must be touching the stops when flaps are retracted (“up”).

Left flap shown in “down” position

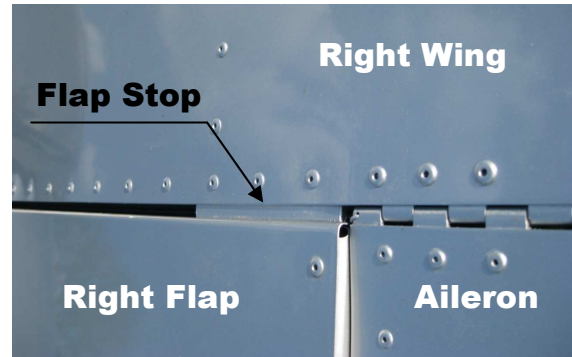
Flap up (against the flap stop)

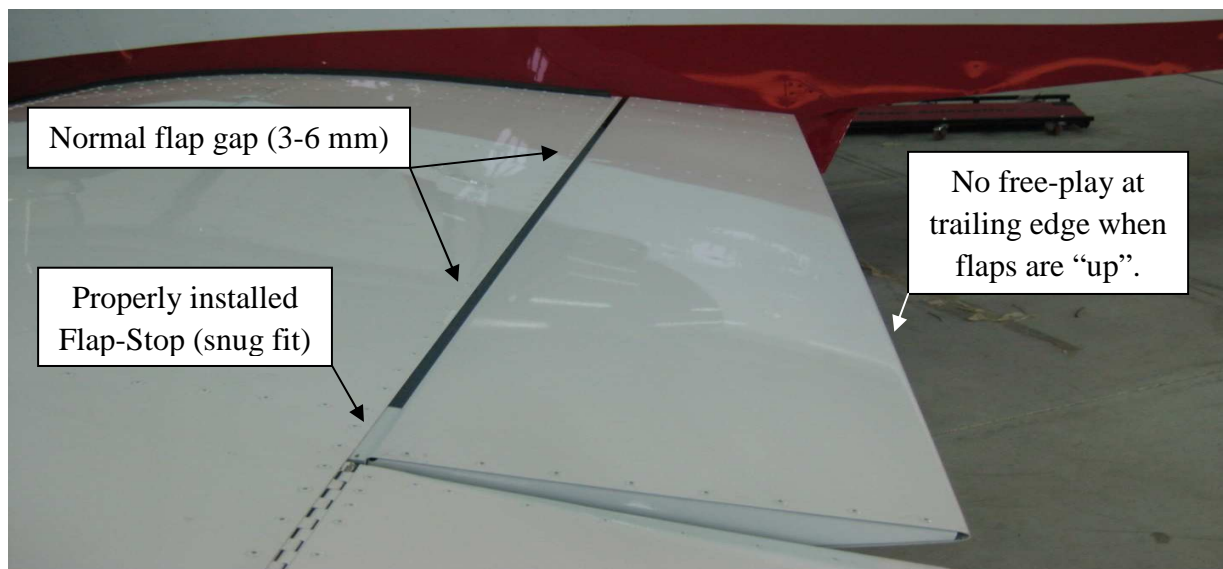
2) There should be no free-play in the flaps when they are in the “up” position (test by applying light up-then-down pressure to the trailing edge). When flap stop (6S3-1) is installed as illustrated, no further action is necessary.
